## ENVIRONMENTAL SITE ASSESSMENT

*San Tomas Business Park  
2600 - 2880 San Tomas Expressway  
Santa Clara, California*

ALLWEST PROJECT No. 25269.20  
November 14, 2005

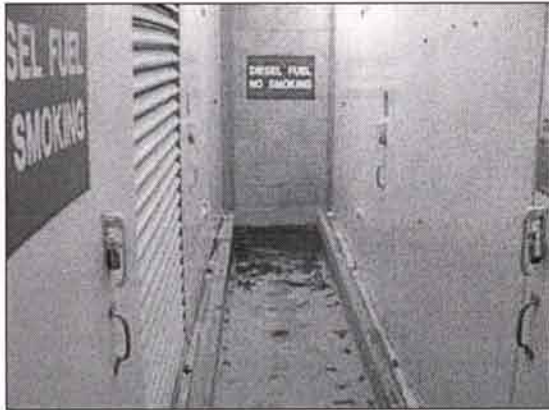
View of the generators

AllWest noted two diesel fueled emergency generators in a shelter immediately west of Building 2. There is a 2,500-gallon diesel AST for the generators in the shelter. No evidence of leaks or spills from the generators or AST was noted.
3. **DISPOSAL:** No evidence of on-site disposal of toxic, inflammable or hazardous materials was observed at the subject property.
4. **UNDERGROUND STORAGE TANKS:** No evidence of underground storage tanks (USTs), such as vent pipes and fill ports, were observed at the subject property. No records of USTs were found in the files at the SCFD.
5. **ABOVE GROUND STORAGE TANKS:** As noted above, there was one 2,500-gallon diesel above ground storage tanks (ASTs) observed at the property. According to SCFD files, the AST was installed circa 1999.

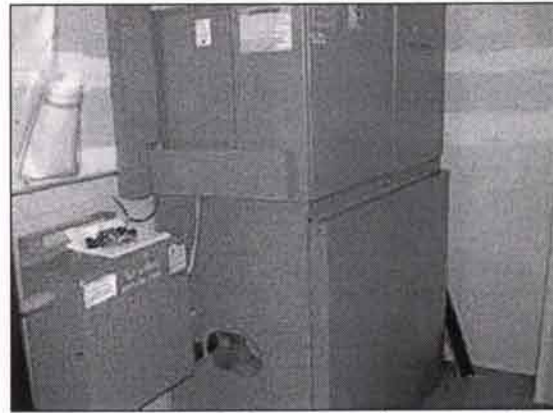
View of typical elevator equipment at the property

Each building is equipped with a hydraulic passenger elevator. No evidence of leaks from the equipment was noted. Based on the date of manufacture (1986), the elevator is not expected to use hydraulic fluids containing PCBs. Other than the emergency generators and associated AST described above, AllWest did not observe any physical evidence of USTs at the property, such as, vent pipes, fill ports, or fill covers.

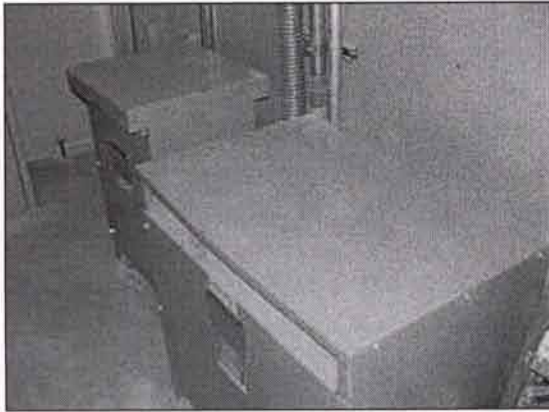
View of typical dry chemical transformers on the property

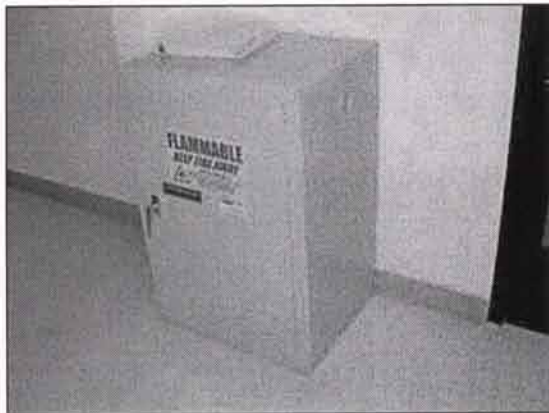
View of a typical flammables storage cabinet on the property

2. **STORAGE:** Small non-regulated amounts of hazardous materials such as household type cleaners, water treatment chemicals, paints, hydraulic oil, roof cement, adhesives, thinner, flux, methanol, acetone and isopropyl alcohol were used by tenants, property management and contractors at the property. The majority of the materials are stored in flammable storage cabinets at Edify and Foveon. A small flammable storage cabinet is located in the storage container used by property management. No pesticides or herbicides were noted on the property. No radioactive materials were noted on the property. No evidence of leaks or spills was noted at the property in the areas where the materials are used and stored.

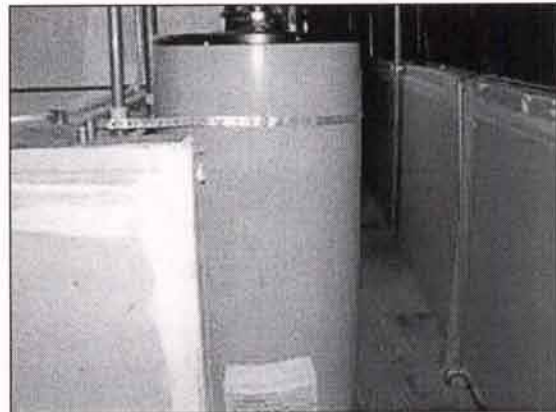
View of a typical water heater on the property

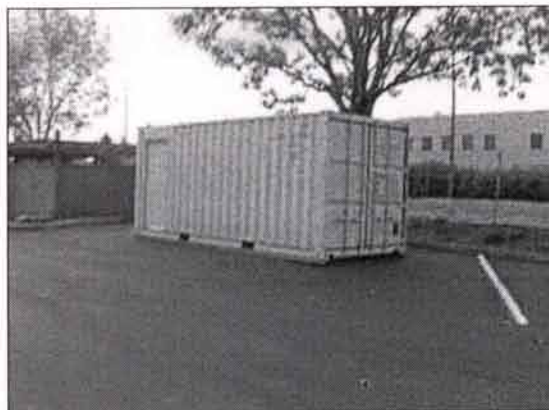
View of the property management storage container

3. **FENCING:** There is fencing separating the property from its northern and western adjacent properties.
4. **STORAGE:** No exterior storage areas were noted at the subject property, except for a storage container along the western property line used by property management for storage of materials.
